Supplementary Materials

Microstructural evolution and fatigue mechanism of 316LN austenitic stainless steel welded joint at 4.2 K

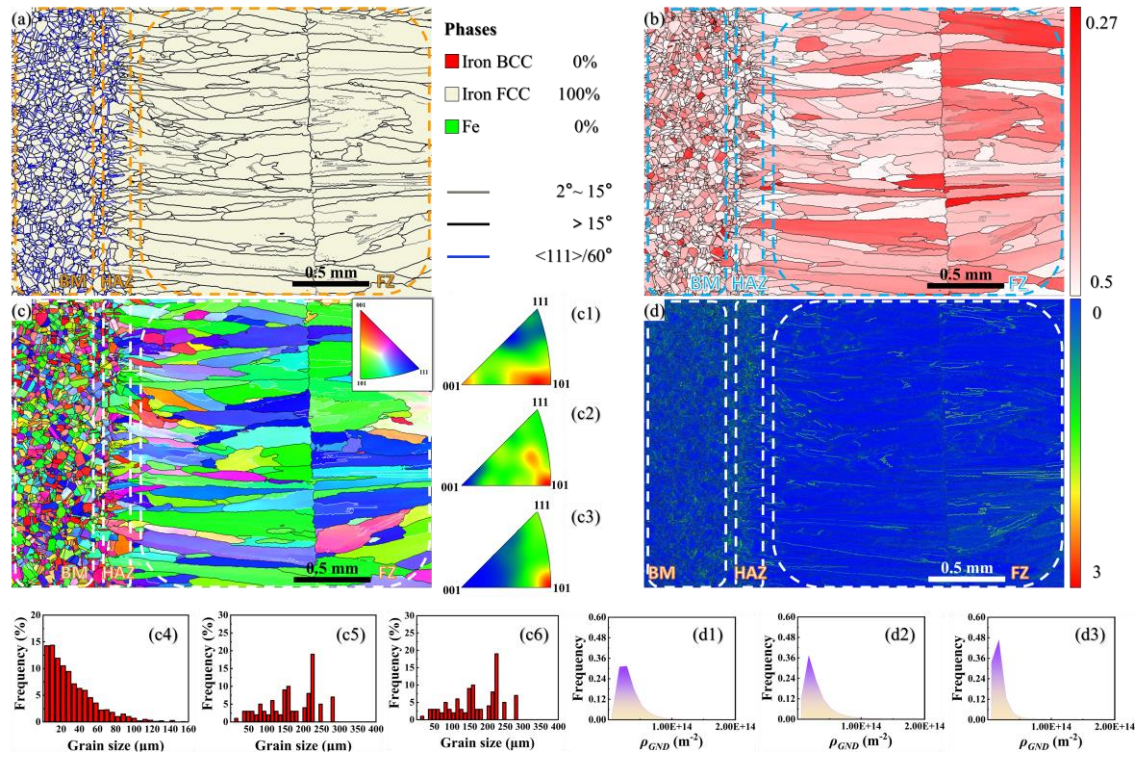
Fig. S1. Microstructure before the fatigue test: (a) Phases map, (b) Schmid factor map, (c-c3) inverse pole figures, (c4-c6) grain size statistical diagrams, (d) Kernel average misorientation map, and (d1-d3) Frequency-Average misorientation diagrams of the initial welded joint.
